Abstract

Restoring data availability at PTP53 Ponta Delgada, Portugal

Restoring data availability at KIP39 Kiribati

Restoring data availability at MXP44 and MXX44, Guerrero Negro Mexico

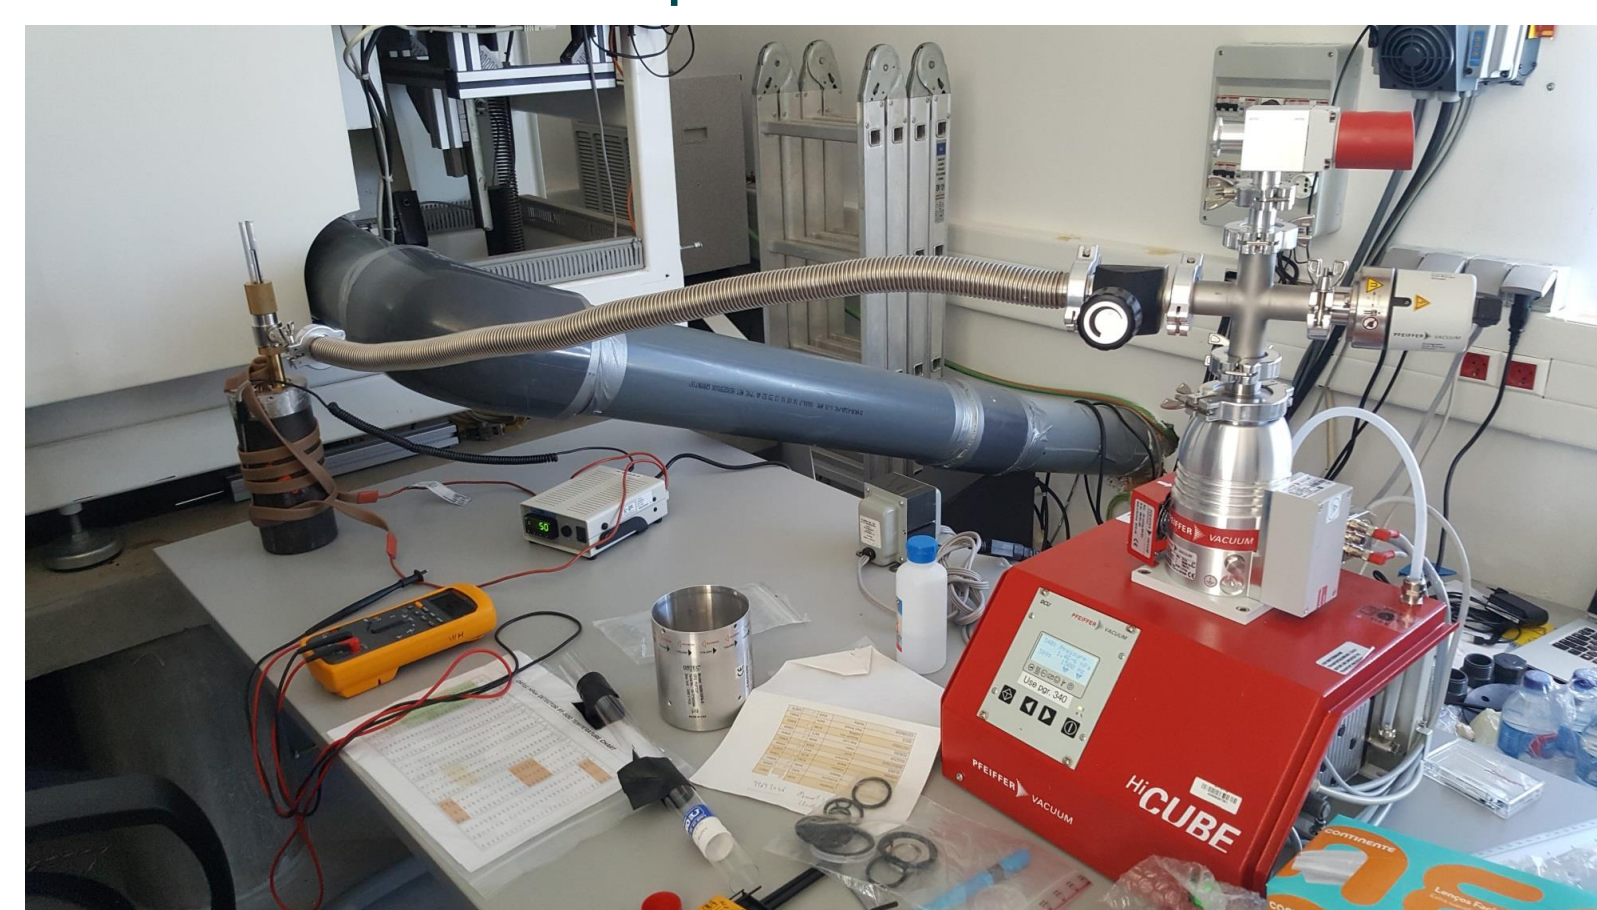
The IMS RN monitoring station at PTP53 Ponta Delgada, Portugal is located inside the airport premises in a marine environment. A prolonged outage occurred at the station due to access limitations at the airport.

Maintenance staff visited the station to restore data availability. Severe corrosion had damaged the air sampler pump which was replaced. Detector vacuum was restored onsite. The station electronics: (Computer, MCA and weather station) were replaced. The station grounding was corrected. A power conditioner was installed, the Cinderella system serviced and the station was restarted. Successful arrangements were made to resume station access for the operators using a follow me car. After our intervention and measures Data availability has been successfully restored.

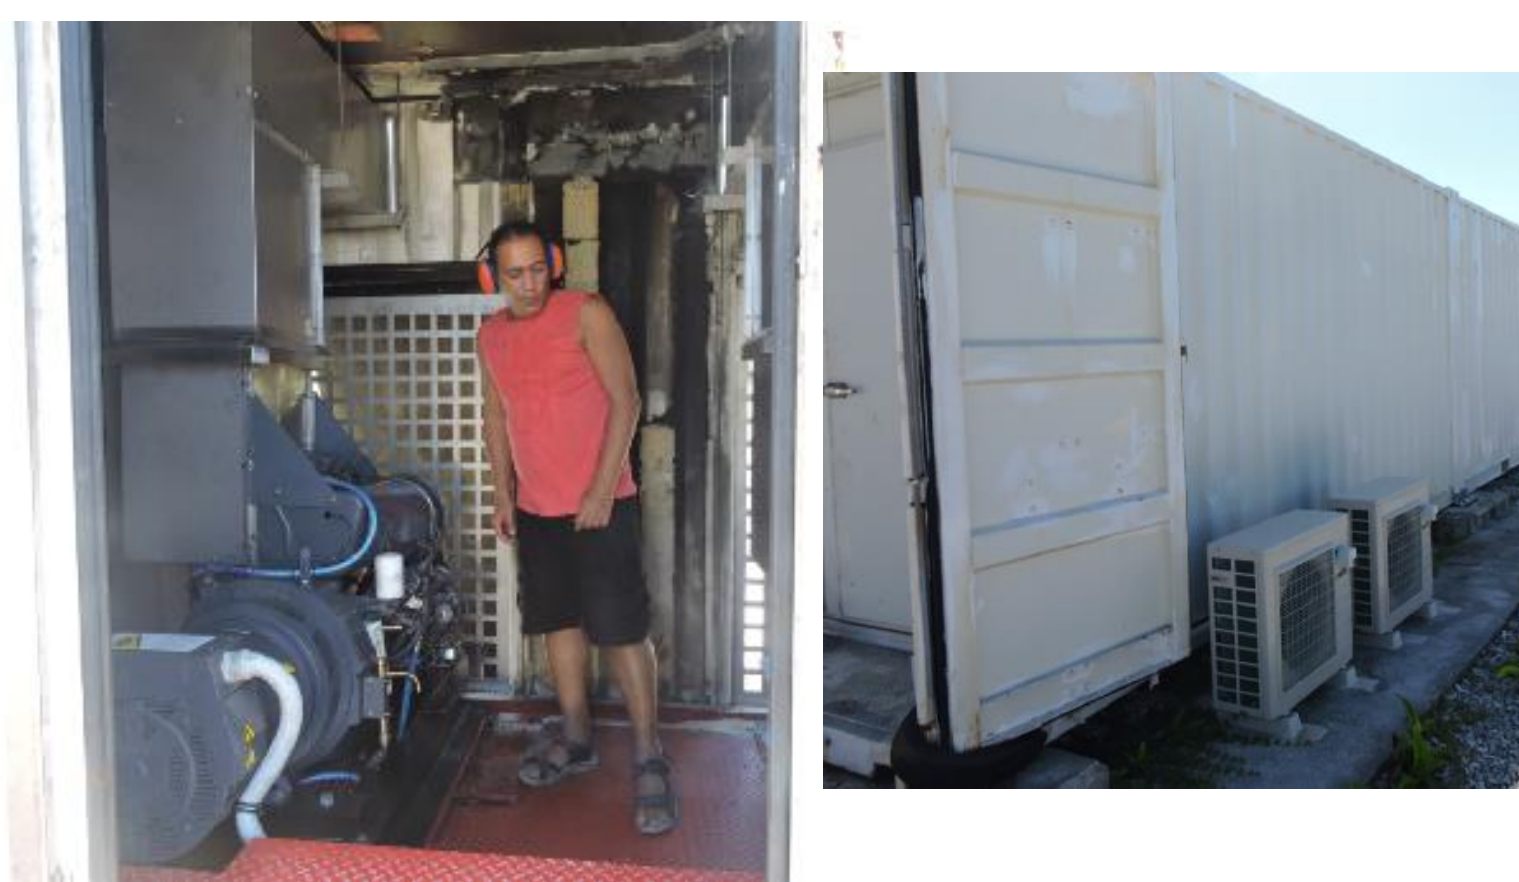
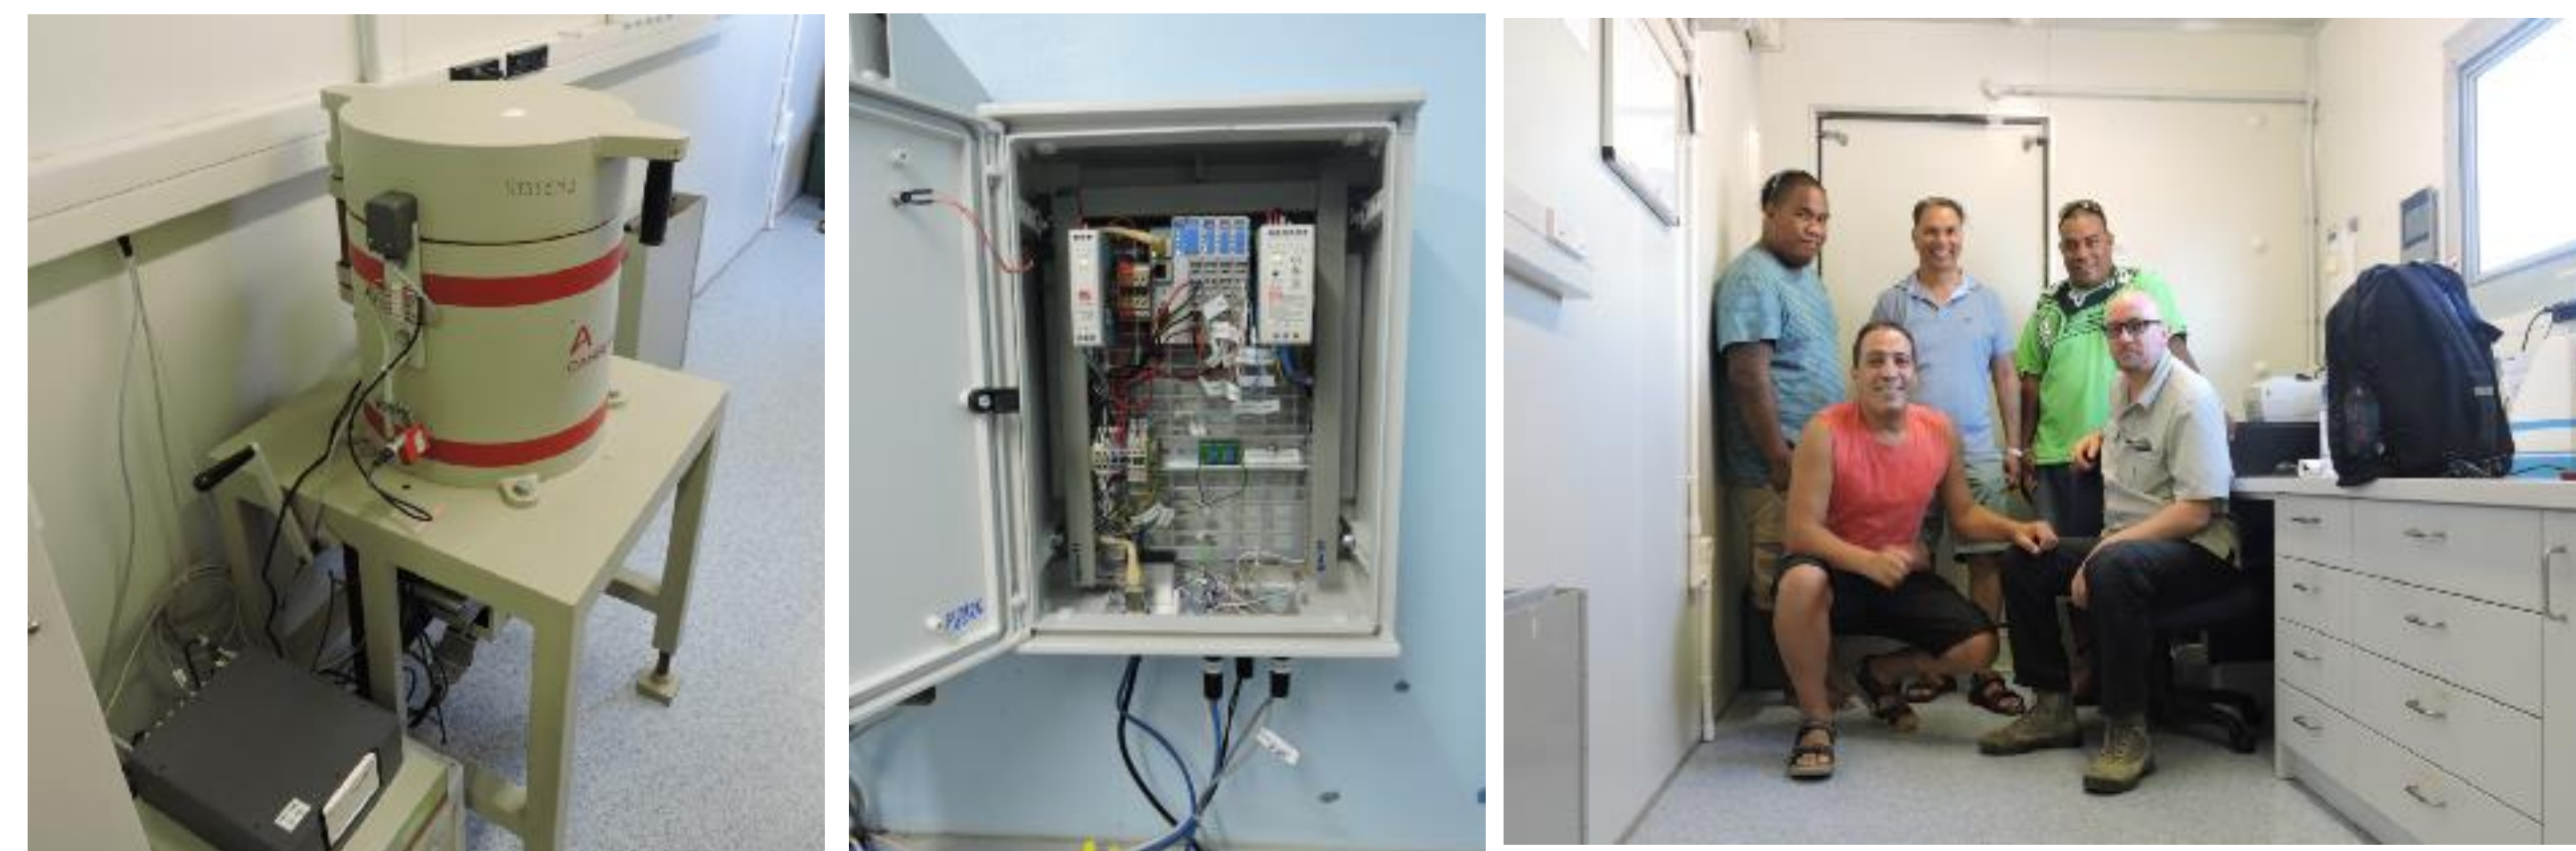
The IMS RN monitoring station at KIP39, Kiribati is located on a small coral atoll in the south pacific. It is uniquely run on diesel generators. Lack of adequate maintenance and a poor choice on the type of generator led to failures of all the generators. The bad power damaged most of the station equipment.

MFS together with ED collaborated with the station operator to restore DA at the station. Two Deutz air cooled generators commonly used in the Islands were procured with specially treated alternators. A ORTEA power conditioner was installed. A SOCOMEC UPS was installed and two new DAIKIN split ACs were installed.

The grounding system was redone, a new HPGe detector, Lynx MCA, station computer, meteo system and DAS were configured and installed during the site visit. Following the visit and intensive onsite training of the local operators, data availability successfully was restored.

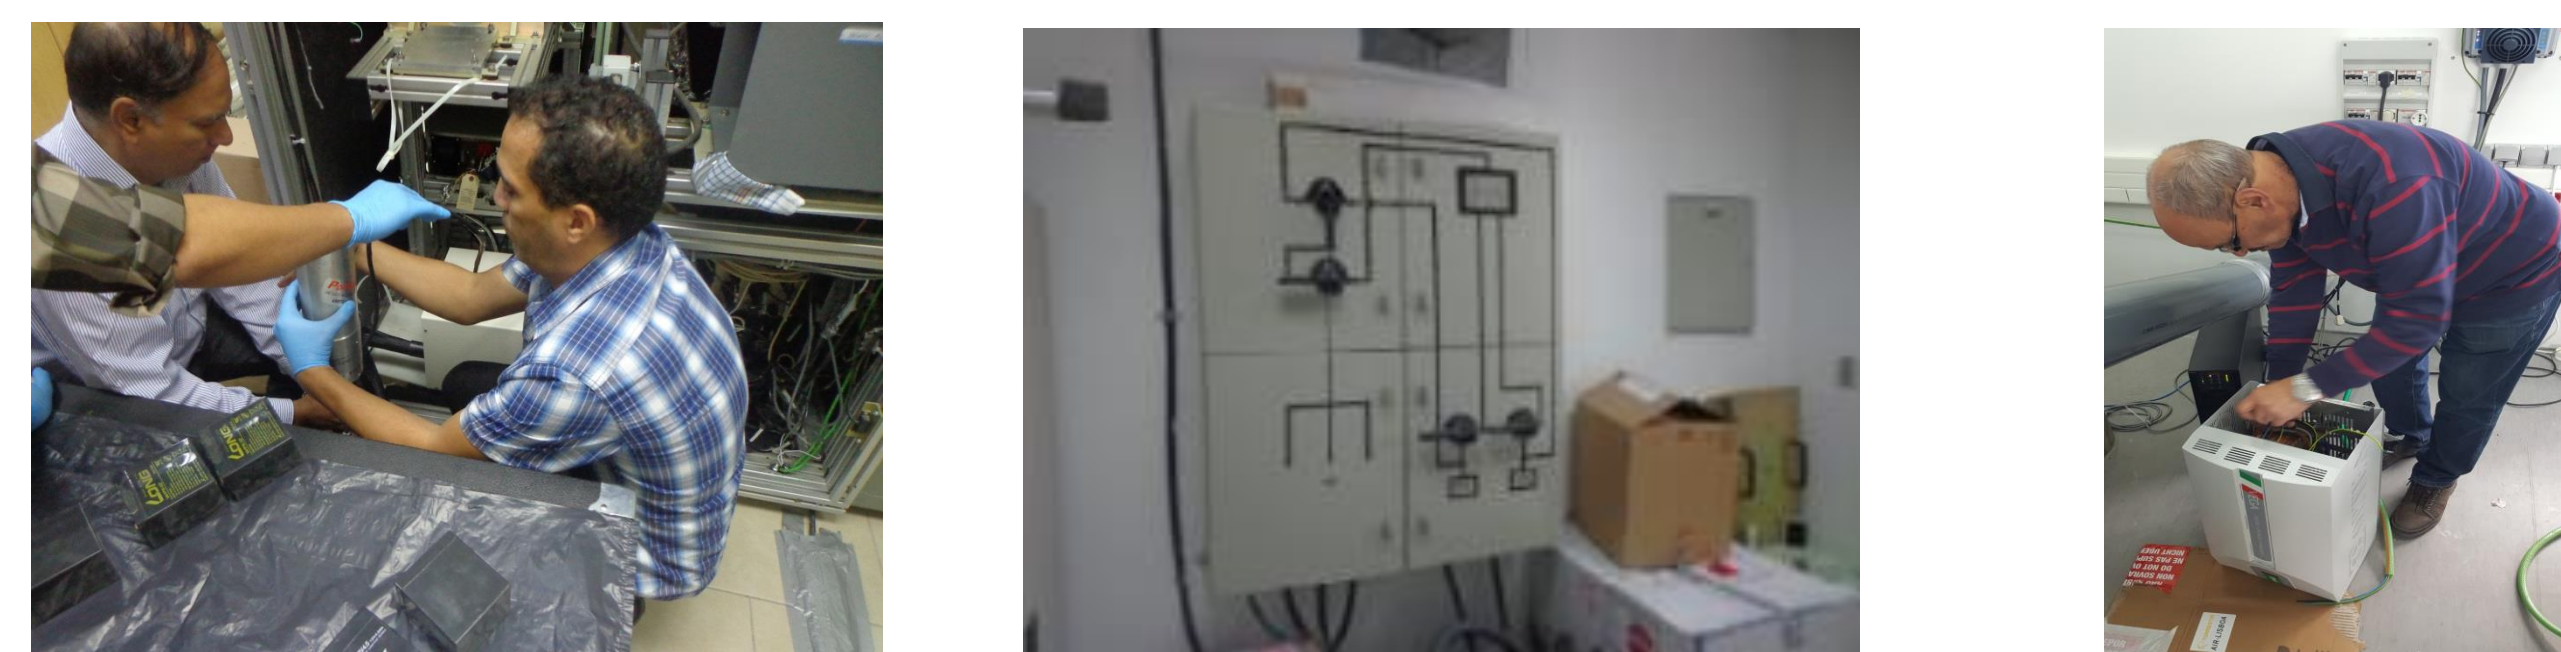
Issues related to bad power have been a frequent cause of station downtime. Most RN stations are equipped with auxiliary generators. Due to inadequate service, large switchover transients or poor supply regulation, Repeated equipment failures have been observed at some stations. These anomalies include damage to UPS systems, gamma detectors and other station electronics.

To prevent this power conditioners have been installed at many RN stations. The additional protection provided has reduced the number of failures and resulted in significantly improved data availability.

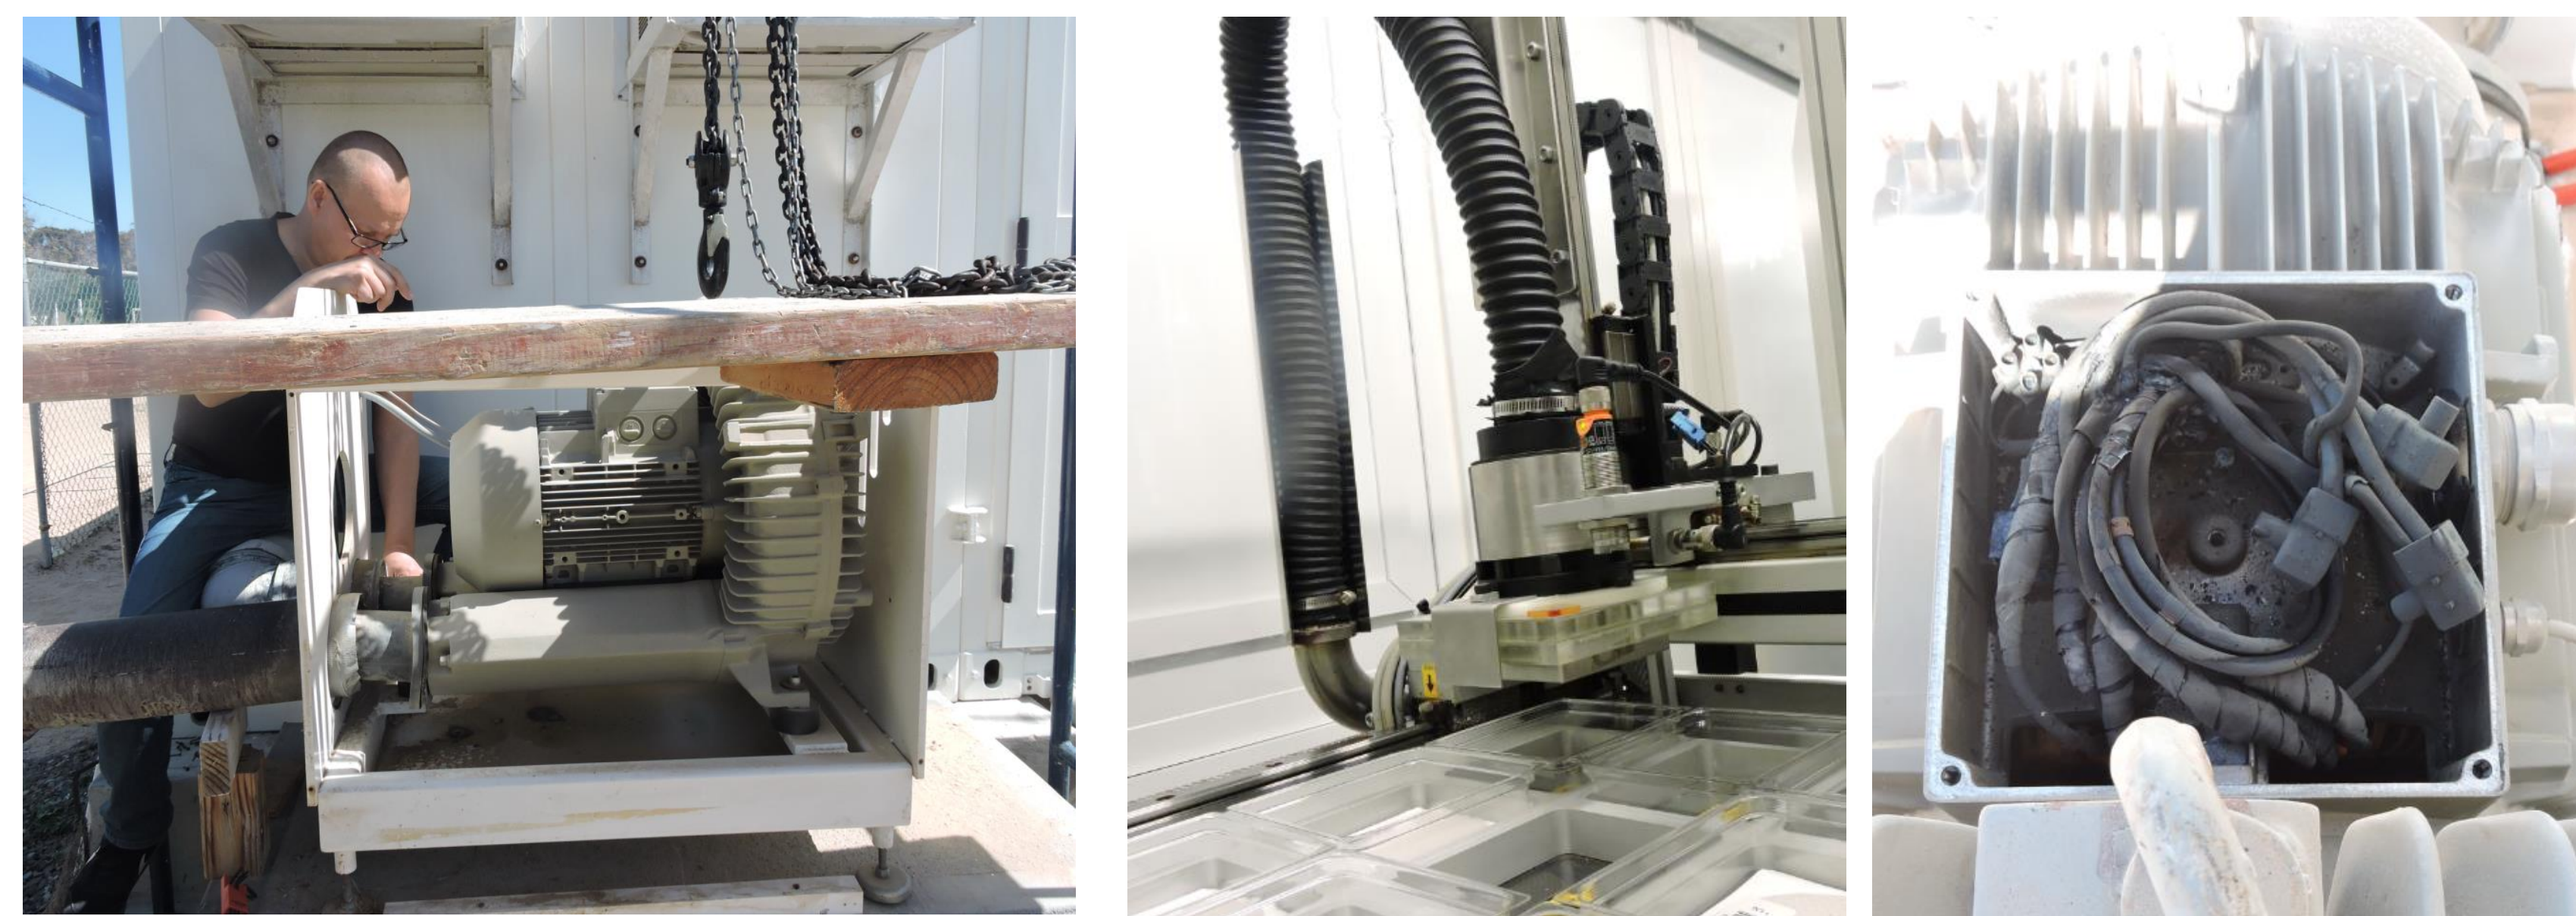
The station suffered from frequent outages related to bad power and poor station infrastructure. During a maintenance visit it was discovered that the air sampler motor wiring was badly burned and the entire air sampler motor and pump will soon be replaced. The motor controller settings were optimized. The station grounding was inspected and found to be incorrectly wired. The grounding errors were fixed.

The Cinderella system was serviced: new sampling chamber installed, new robot arm cutting blades installed, a new pump housing will be installed, the vacuum motor was repaired.
