1 Station FJP26 located in Nadi, Fiji. The station experienced multiple detector related problems since the ELAN generator was installed. The resolution was poor, unstable and exceeded the minimum IMS requirement of 2.5keV FWHM at the 1332.5 keV Co60 peak. The detector showed clear signs of loss of vacuum with water condensing on detector head. At the same time, electronic noise or leakage currents made the spectra unstable and sometimes unsuitable for analysis. The detector was a liquid nitrogen (LN) cooled detector with LN supplied by an ELAN LN generator. The ELAN LN generator had frequent problems supplying sufficient amounts of LN to cool the detector.

4 The AS031/MSVF station is an Incorporated Research Institutions for Seismology (IRIS) and International Deployment of Accelerometers (IDA) configured seismic station where a Standard Station Interface (SSI) acquisition computer from CTBTO authenticates and forwards the data from the IRIS/IDA equipment to CTBTO. The SSI computer was down for a long period of time for unknown reasons and could not be restored remotely or locally by the Station Operator. At the same time, the IRIS/IDA network was receiving data and did not show

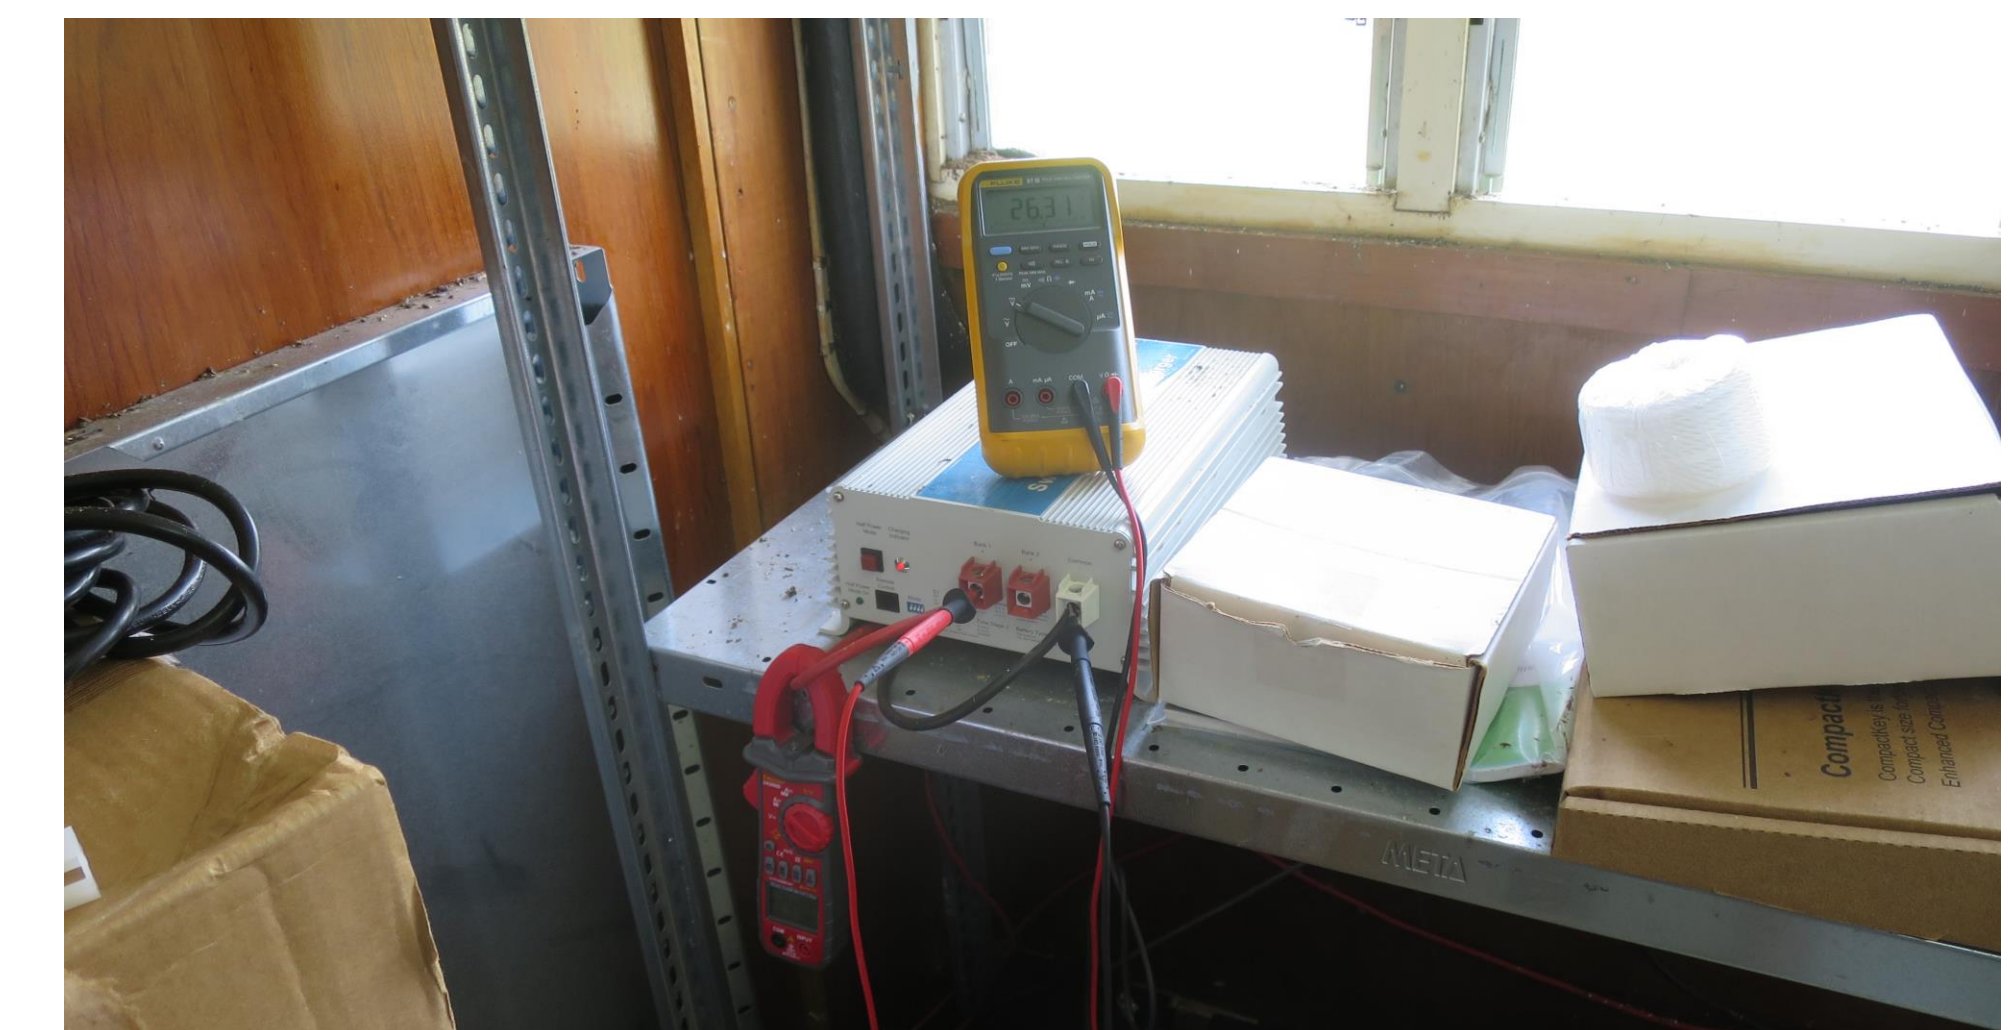
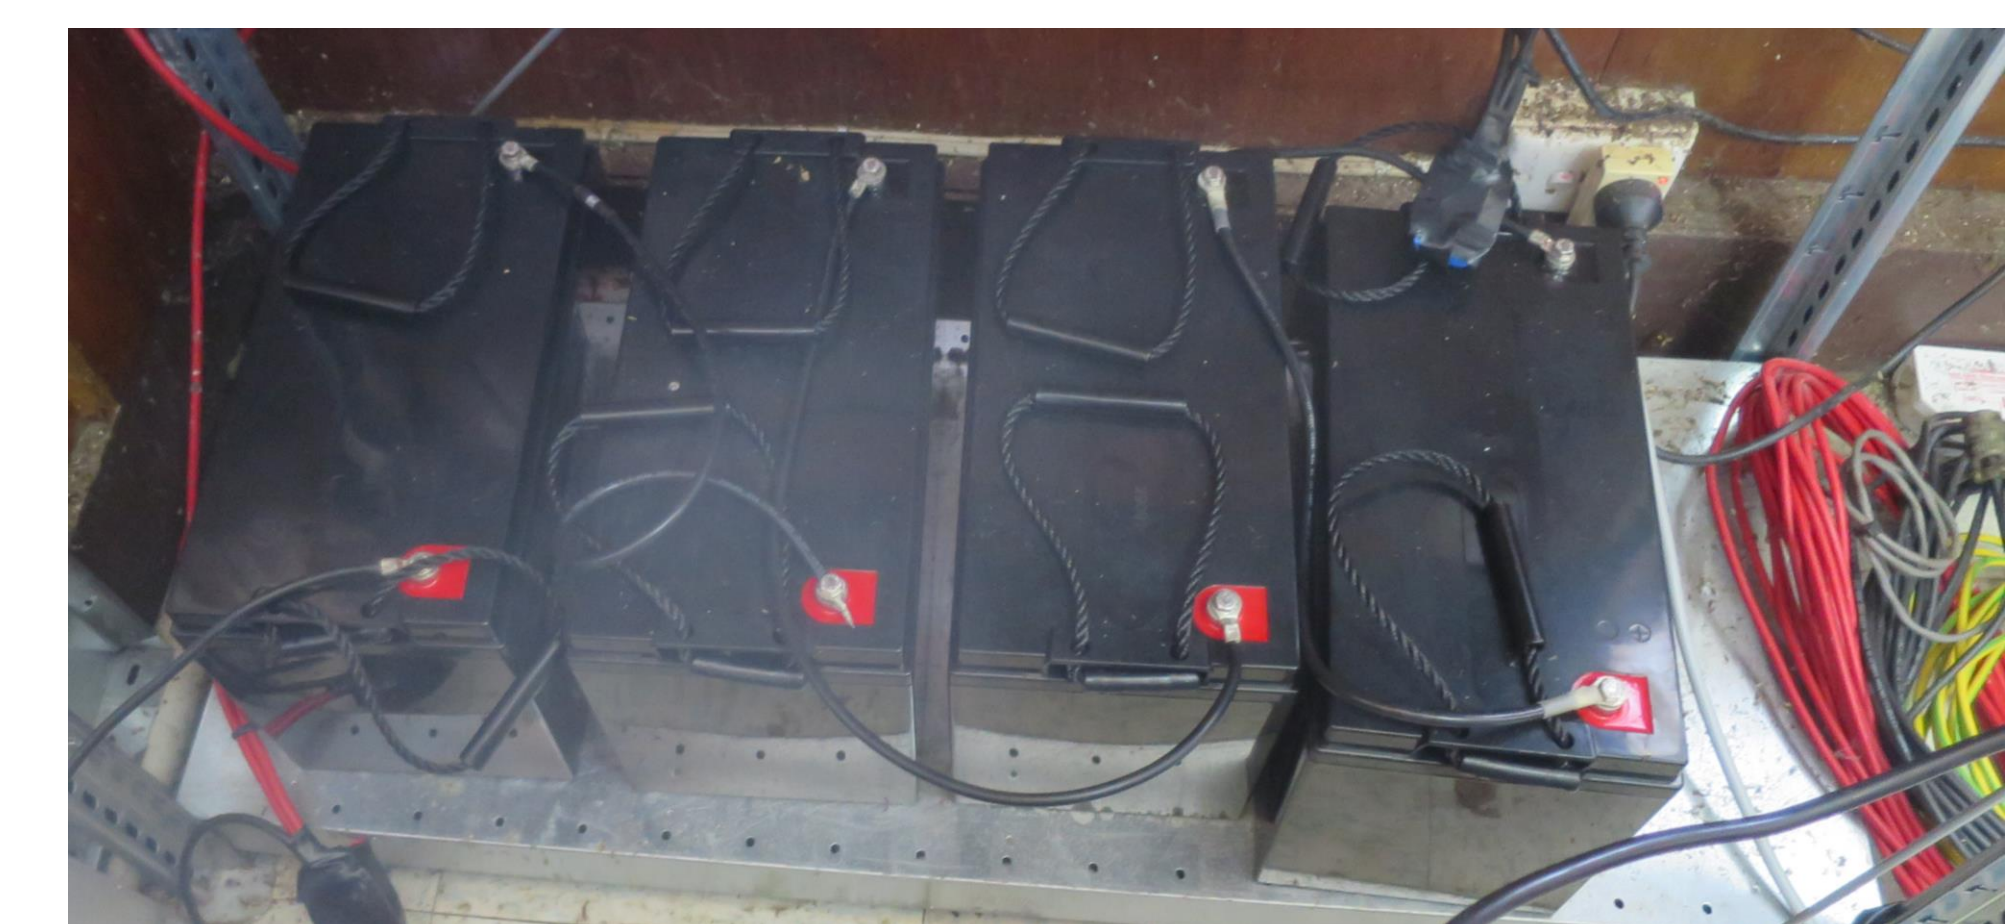
5 The AS031/MSVF station is located near the Monasavu hydro plant in the middle of the Viti Levu Island. The travel to the AS031/MSVF station is a time consuming drive through mountainous regions. Upon arrival, it was found that the reason for failure was to lack of power to the CTBTO equipment, although power to the rest of the facility was intact and stable. Further troubleshooting showed problems with the power configuration that arose after a battery change. A 24Vdc system was accidentally configured to 48Vdc. This configuration had damaged the battery charger, the low voltage disconnect unit and power supply to the computer monitor.
