Infrasound Detection Capability Improvement on Wind Noise Reduction System

T4.1-P016

Introduction: Station IS02 is a 5 element infrasound IMS infrastructure certified in August 2006 located in a small town called Tolhuin in the southernmost province of Argentina, Tierra del Fuego. It was constructed in 2004, reconstructed because of flooding in the subterranean vaults in 2006 and more recently a mayor reengineered upgrade in 2010, replacing underground vaults with housing vaults and a new geometry on the wind reduction system of all sites.

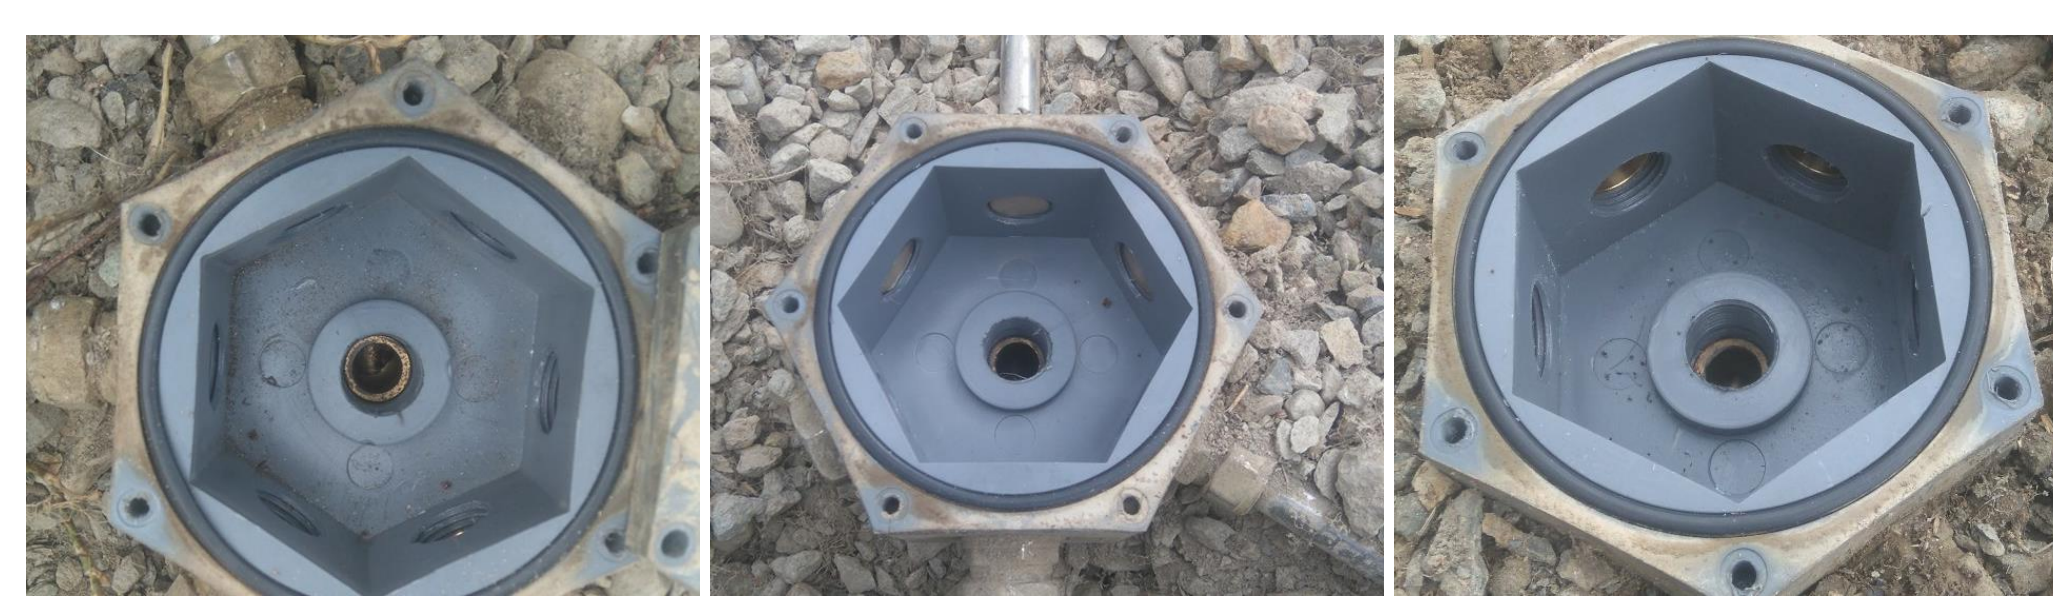
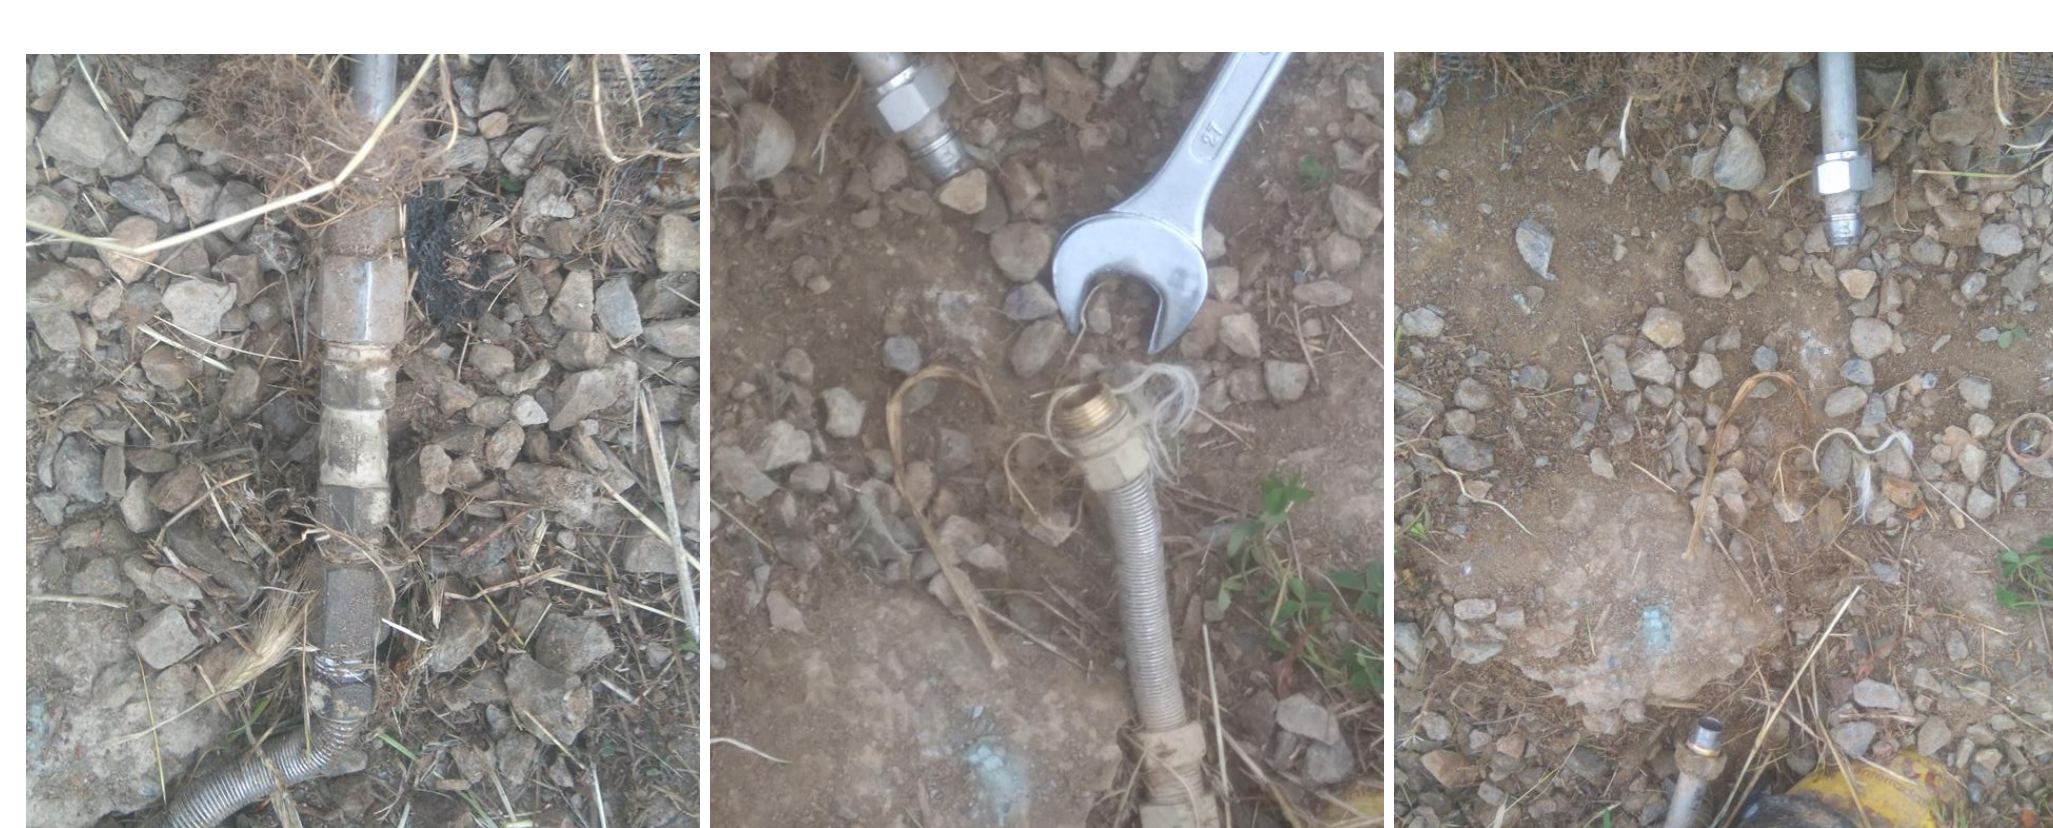
The Visit: During the maintenance our first step was to make a visual observation of the scenarios to know how to apply the submitted instructions. No valves were found in the end of the pipes to close the system and inside some manifolds had some drops of water.

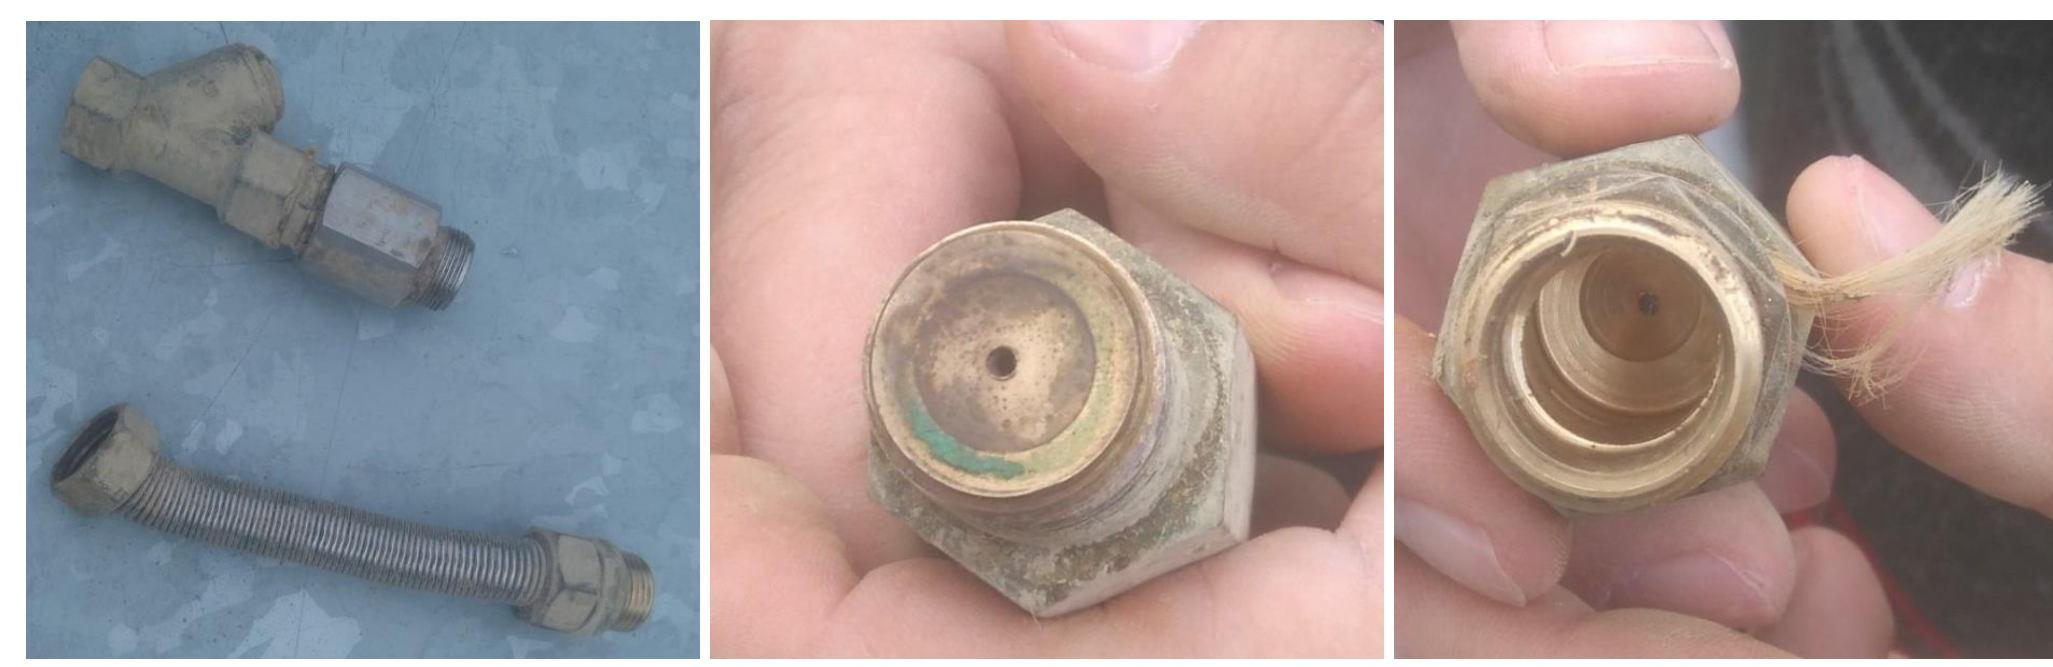
Flexible pipe and resonance suppressor of main line connected to micro barometer dry.

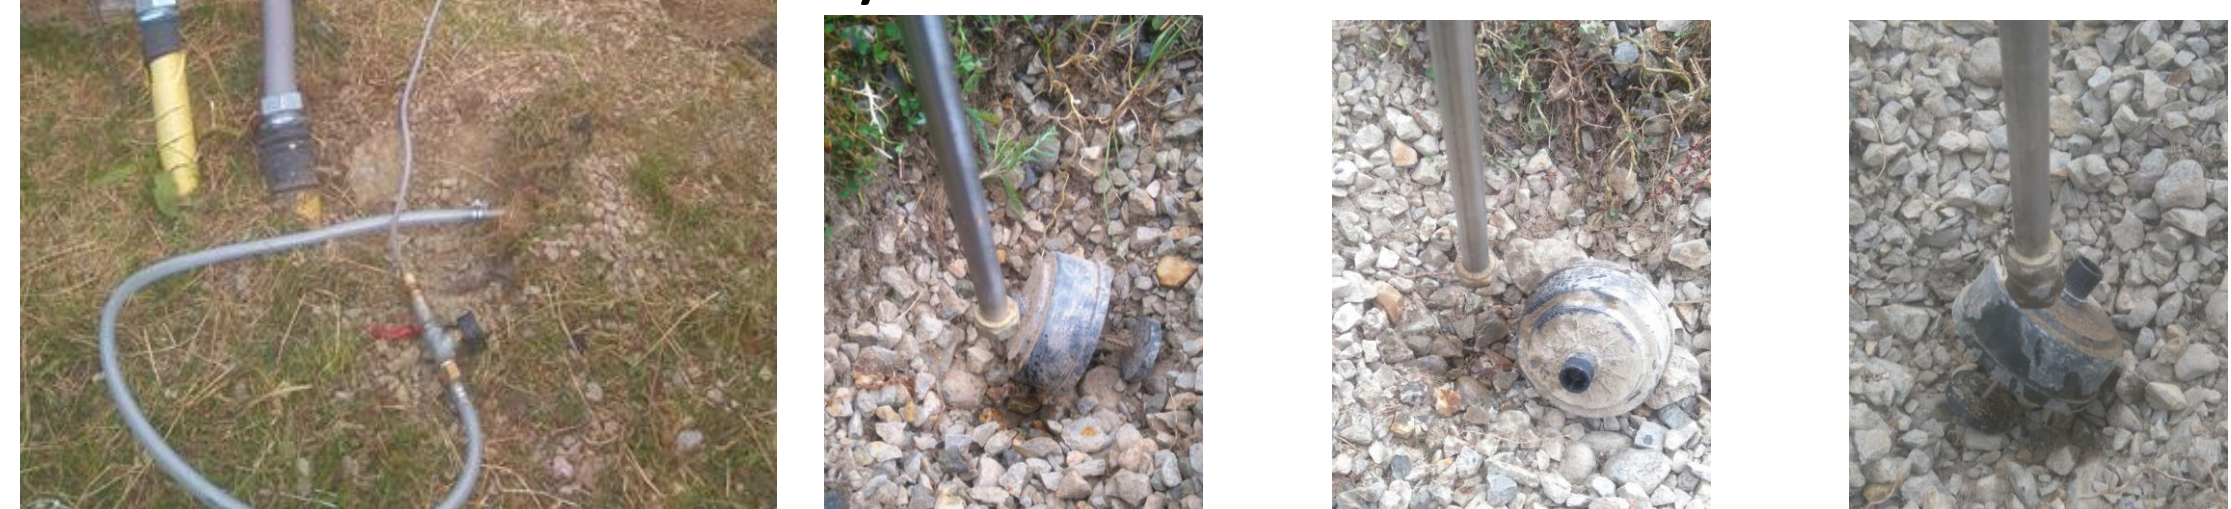
Air compressor was connected to the main line where the micro barometer should be connected and air injected to the system. Some of the knobs were lose and a small amount of water was taken out of the array. The mayor problem during this test was that it was impossible to have enough pressure, or any pressure at all in the system, and the loud noise of air leakages in the whole site. The only way to isolate each of the branches of the array geometry was to cover 5 of the 6 holes in the main hexagonal manifold and start working and repairing one by one.

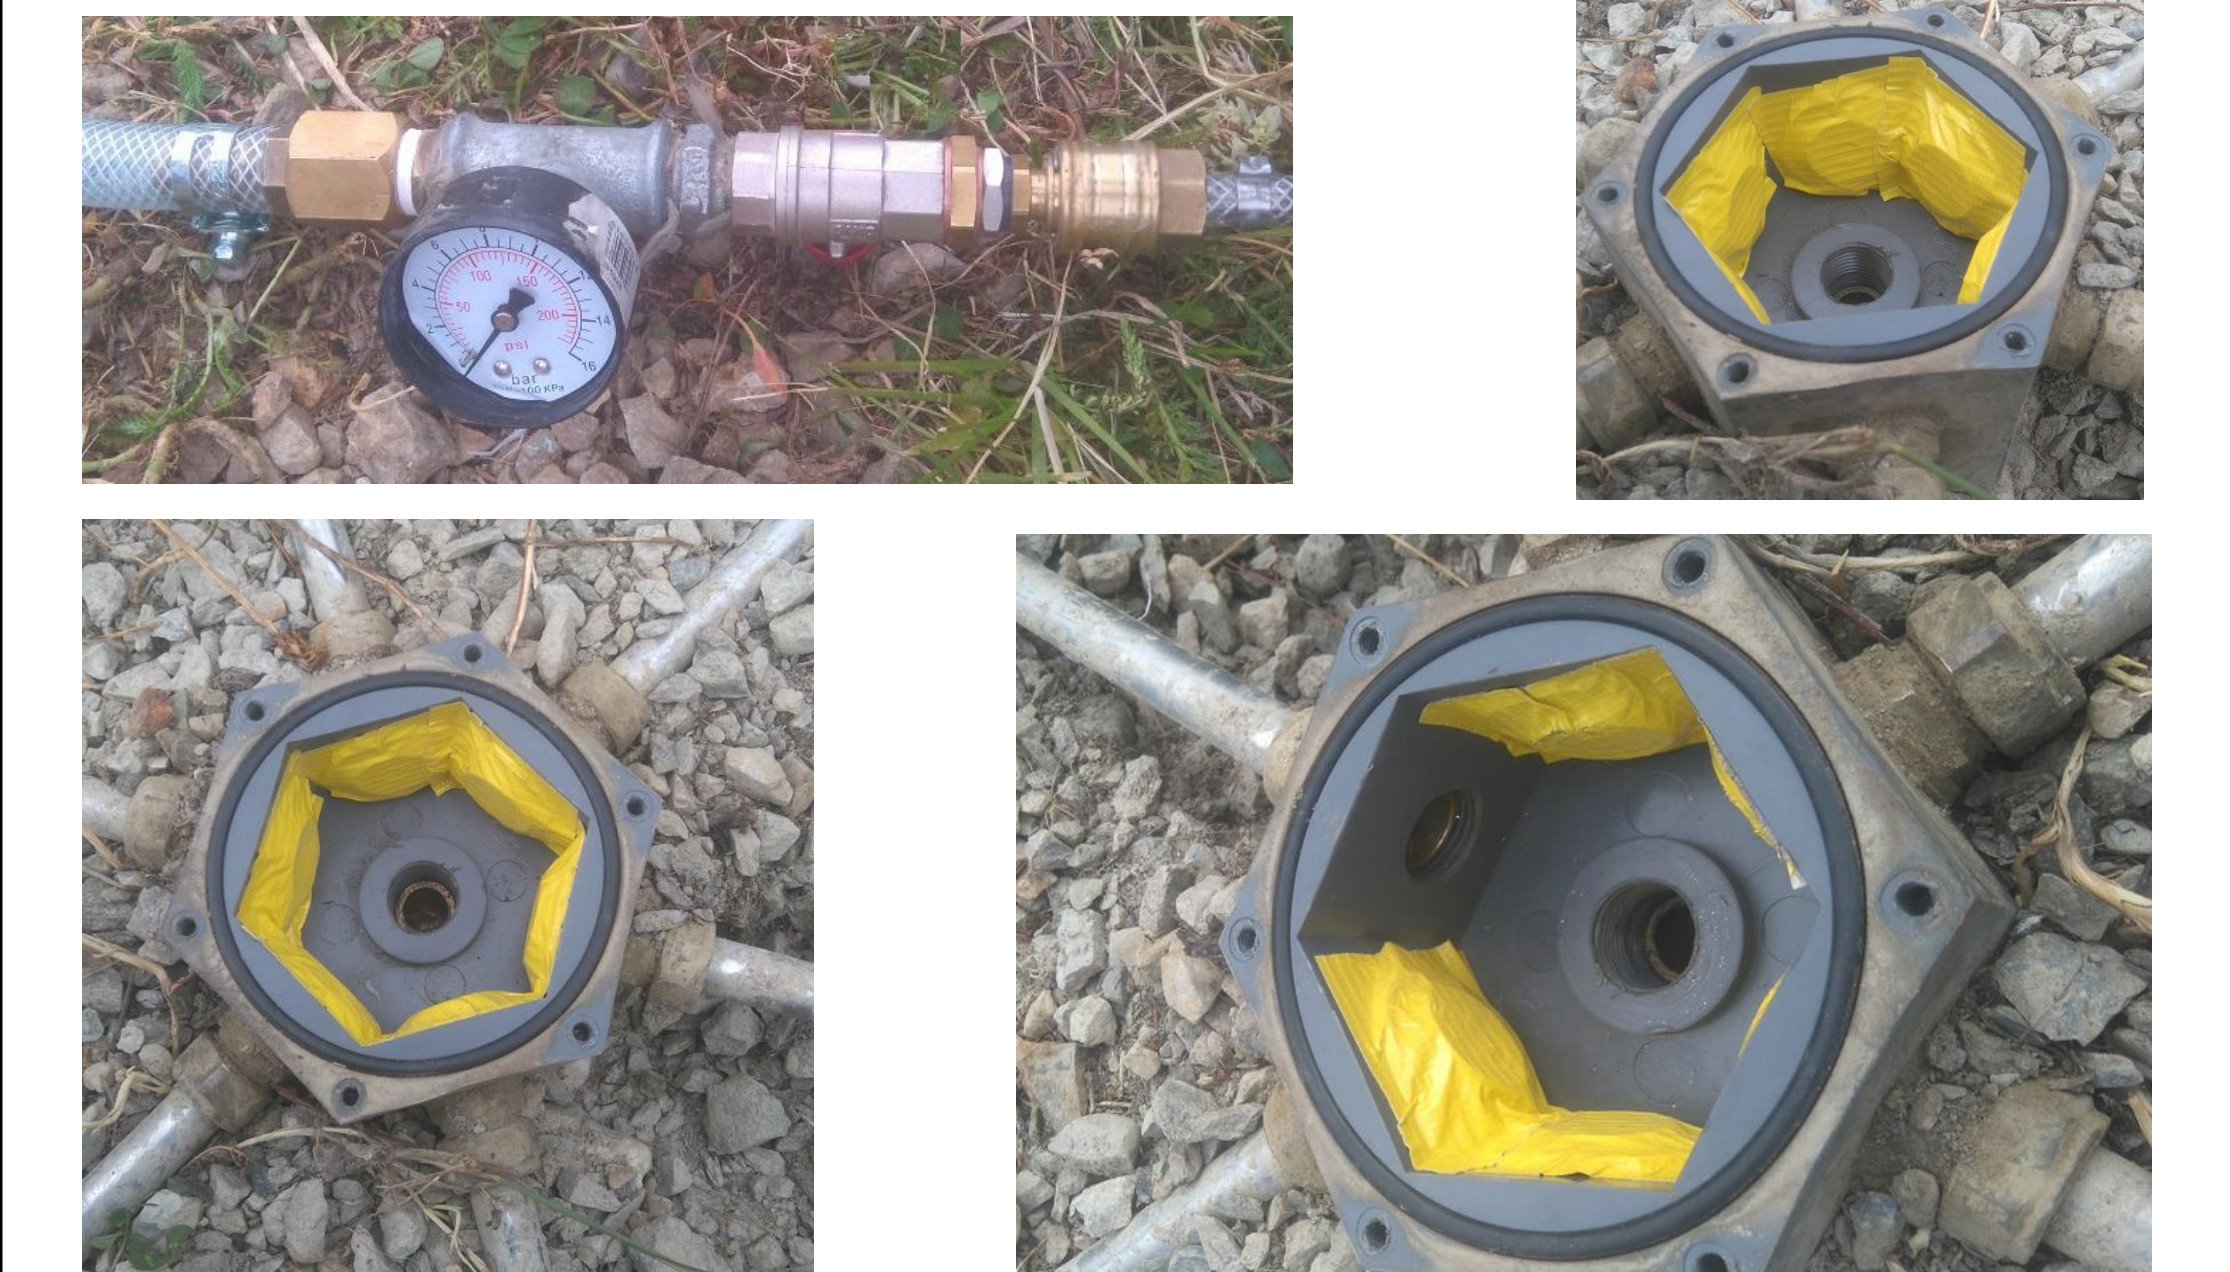
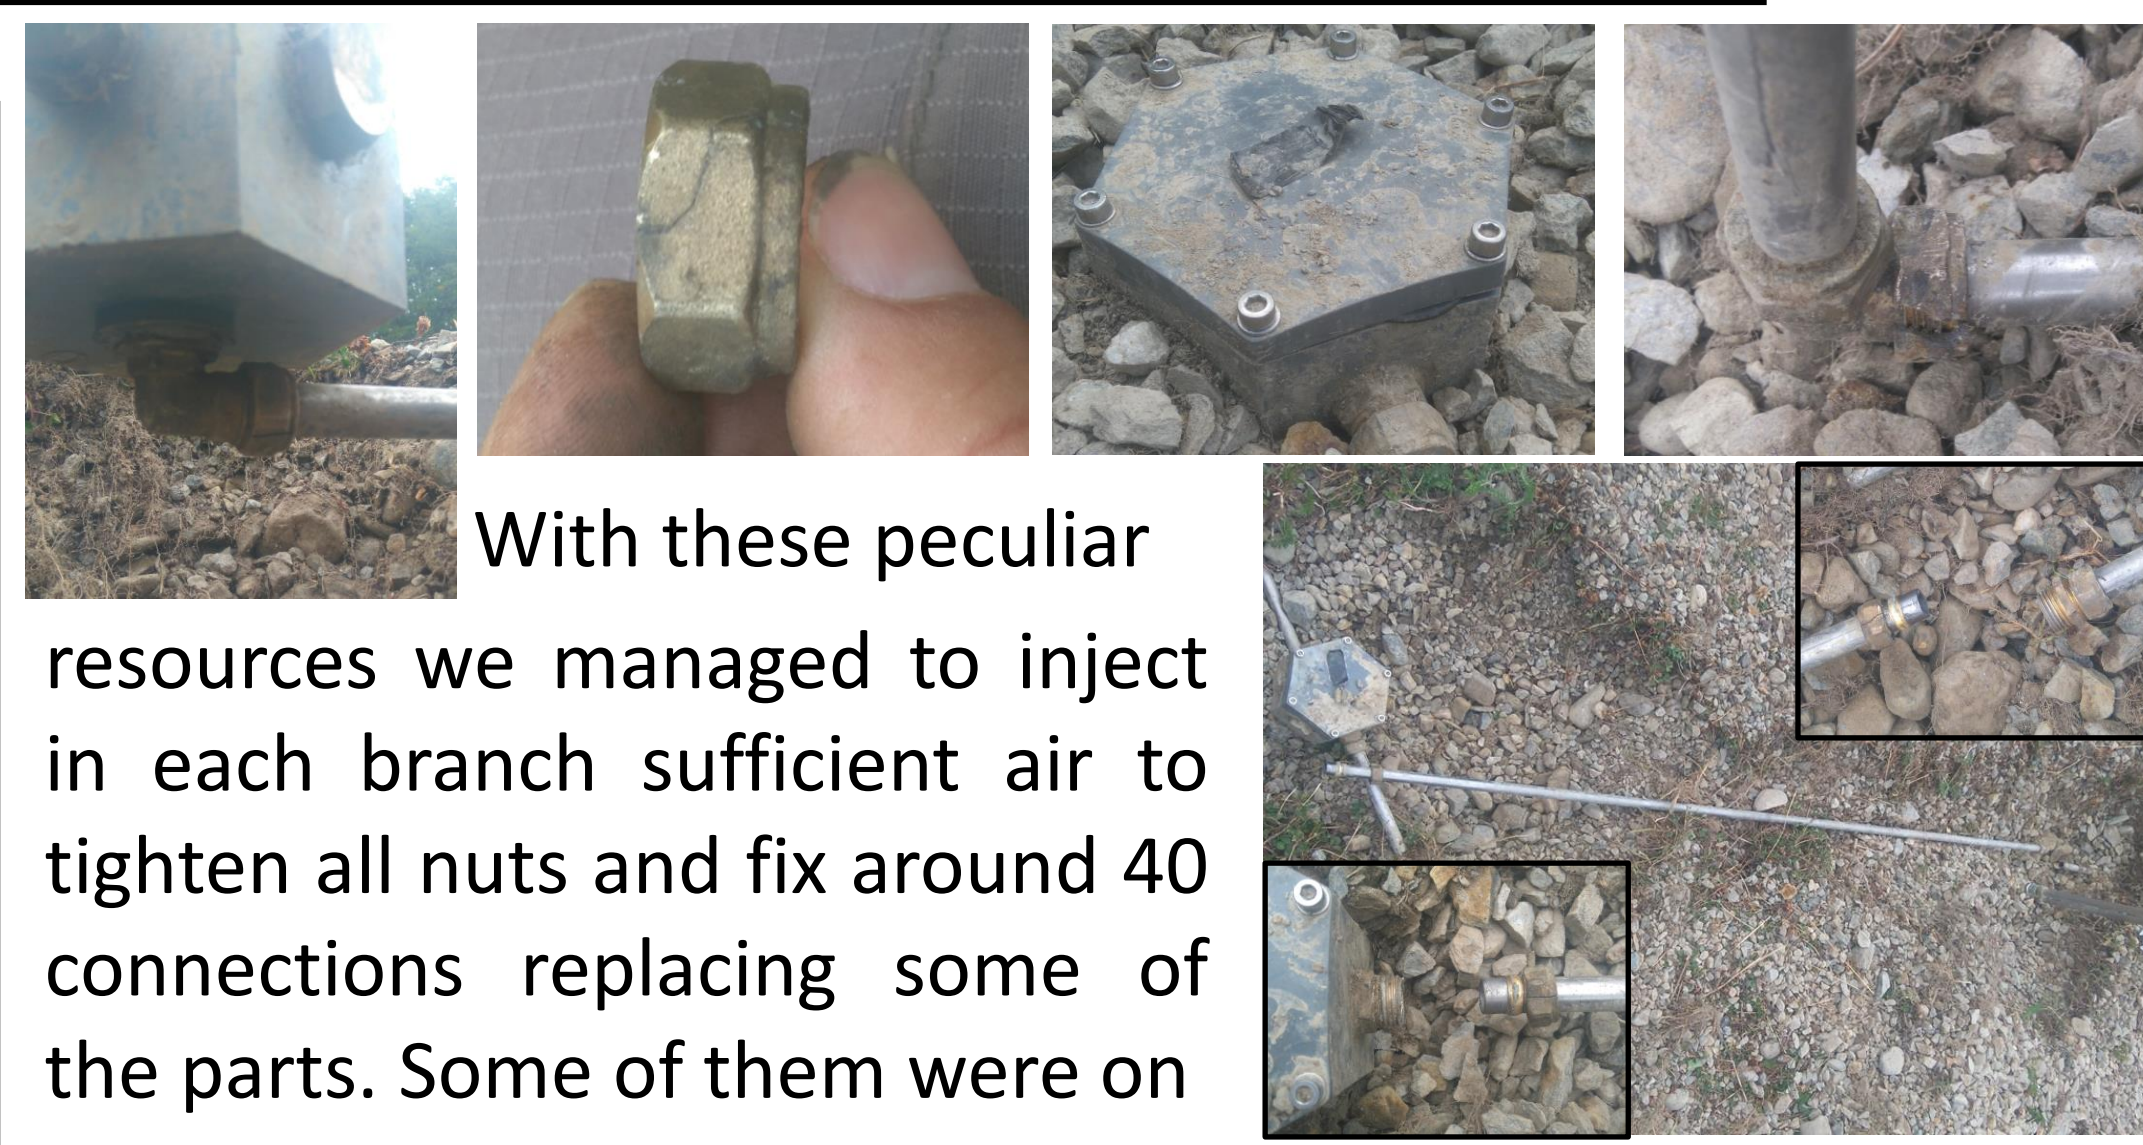
Sealing each branch of the array and applying air with the compressor we started finding a lot of connection with leakages because the nuts where not tight or cracked. In one of the branches a secondary manifold O-ring was always spit out due to the screws of the top.

With these peculiar resources we managed to inject in each branch sufficient air to tighten all nuts and fix around 40 connections replacing some of the parts. Some of them were on the bottom of the secondary manifolds having to dig in the gravel 30 to 40 centimeters down.
