Abstract

Restoring data availability at PTP53 Ponta Delgada, Portugal

Restoring data availability at KIP39 Kiribati

Restoring data availability at MXP44 and MXX44, Guerrero Negro Mexico

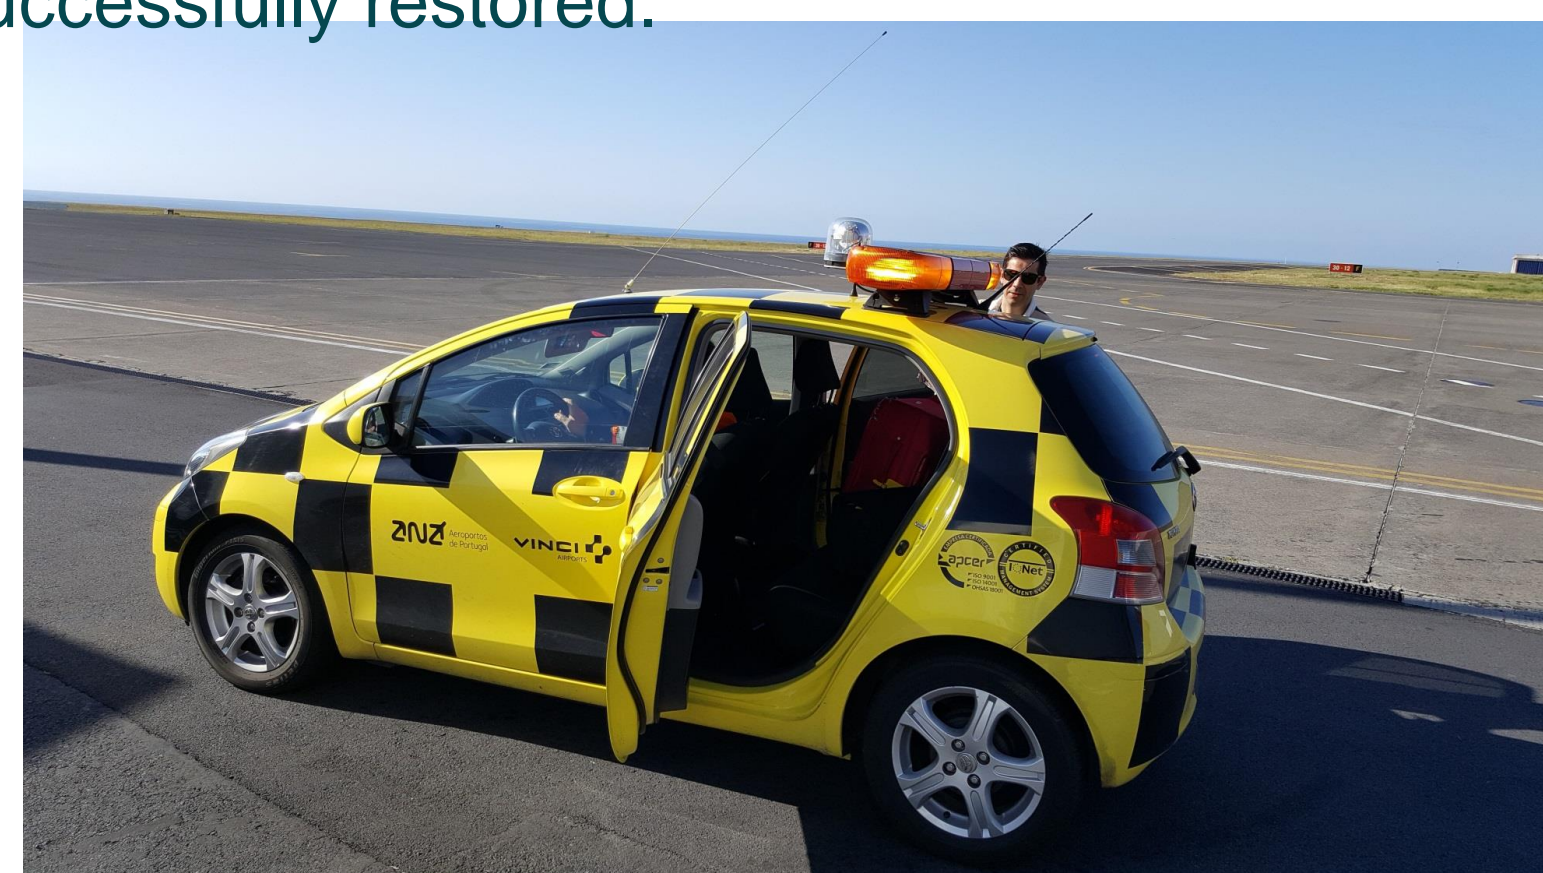
Maintenance staff visited the station to restore data availability. Severe corrosion had damaged the air sampler pump which was replaced. Detector vacuum was restored onsite. The station electronics: (Computer, MCA and weather station) were replaced. The station grounding was corrected. A power conditioner was installed, the Cinderella system serviced and the station was restarted. Successful arrangements were made to resume station access for the operators using a follow me car. After our intervention and measures Data availability has been successfully restored.
