Infrasound Detection Capability Improvement on Wind Noise Reduction System

T4.1-P016

Introduction: Station IS02 is a 5 element infrasound IMS infrastructure certified in August 2006 located in a small town called Tolhuin in the southernmost province of Argentina, Tierra del Fuego. It was constructed in 2004, reconstructed because of flooding in the subterranean vaults in 2006 and more recently a mayor reengineered upgrade in 2010, replacing underground vaults with housing vaults and a new geometry on the wind reduction system of all sites.

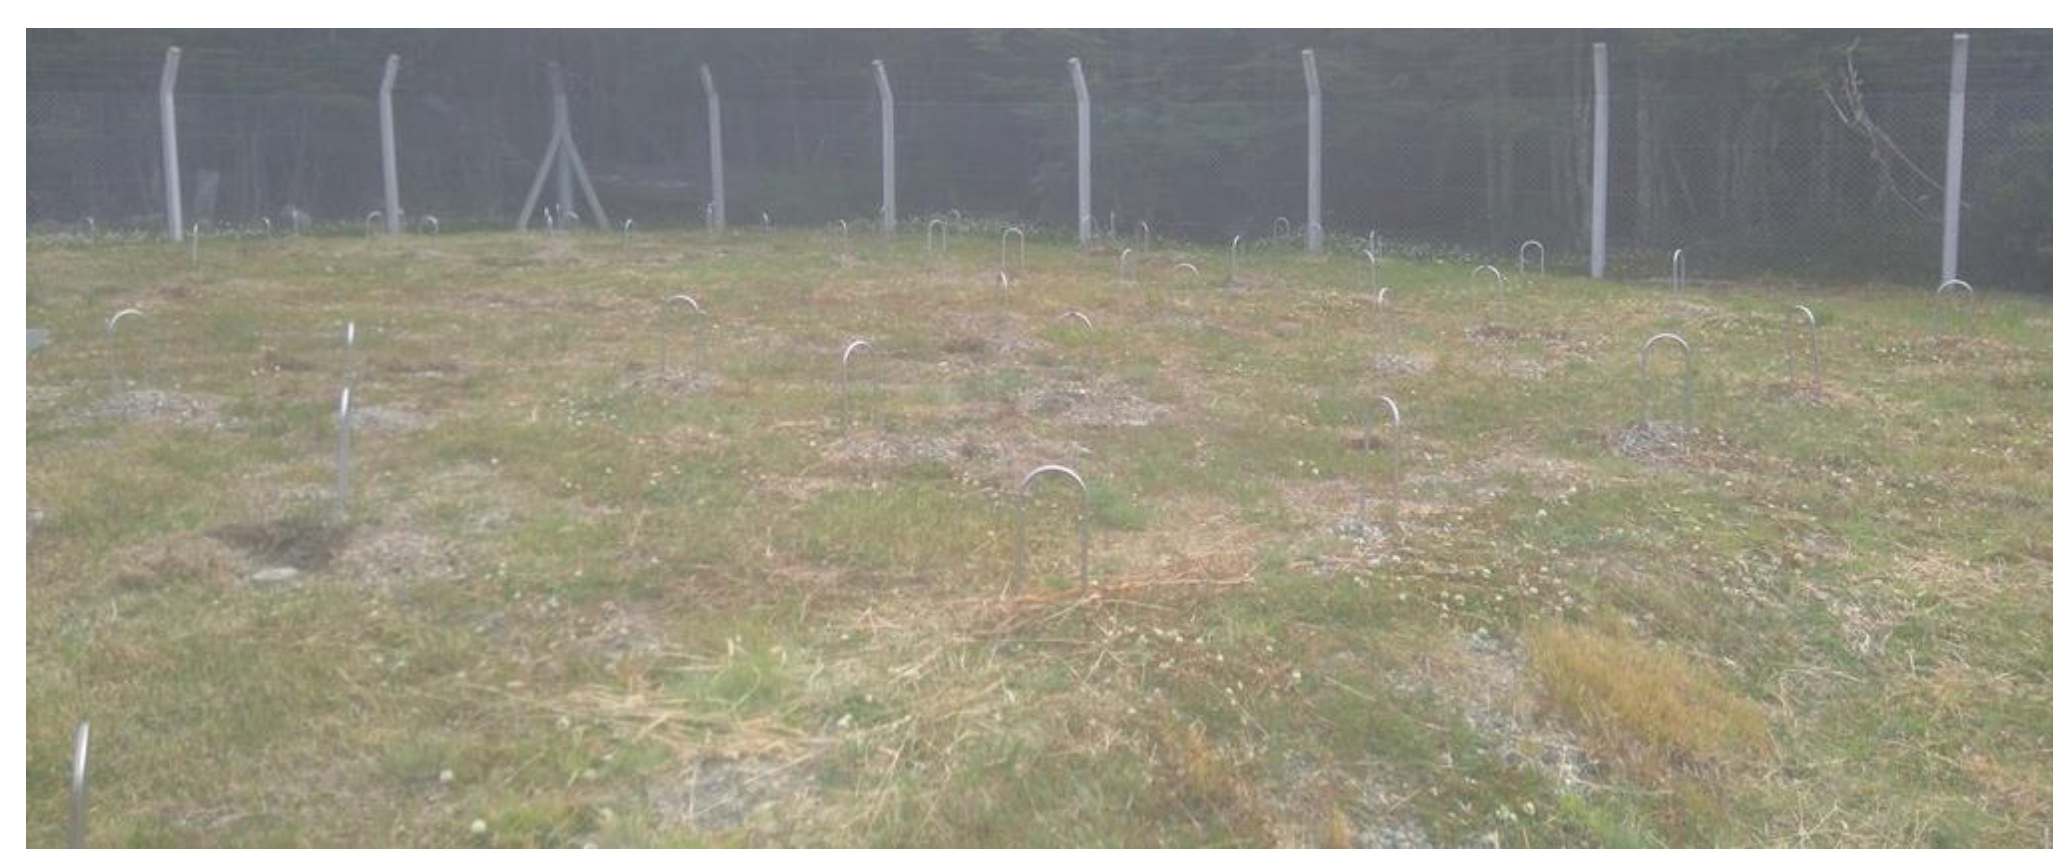
Planning the visit: After some months of planning, while we waited for the snowy season to pass, a week visit was scheduled for February 2016. Specific instructions were submitted to perform in H5 site. Procedure was expected to be quite simple...
 All valves were closed to perform a pressure test disconnecting Micro Barometer from the array and pressurizing the system up to 2-3 bar for about 10 minutes, opening each valve expecting some water out in some of them and repeating this opening in all 72 valves individually.

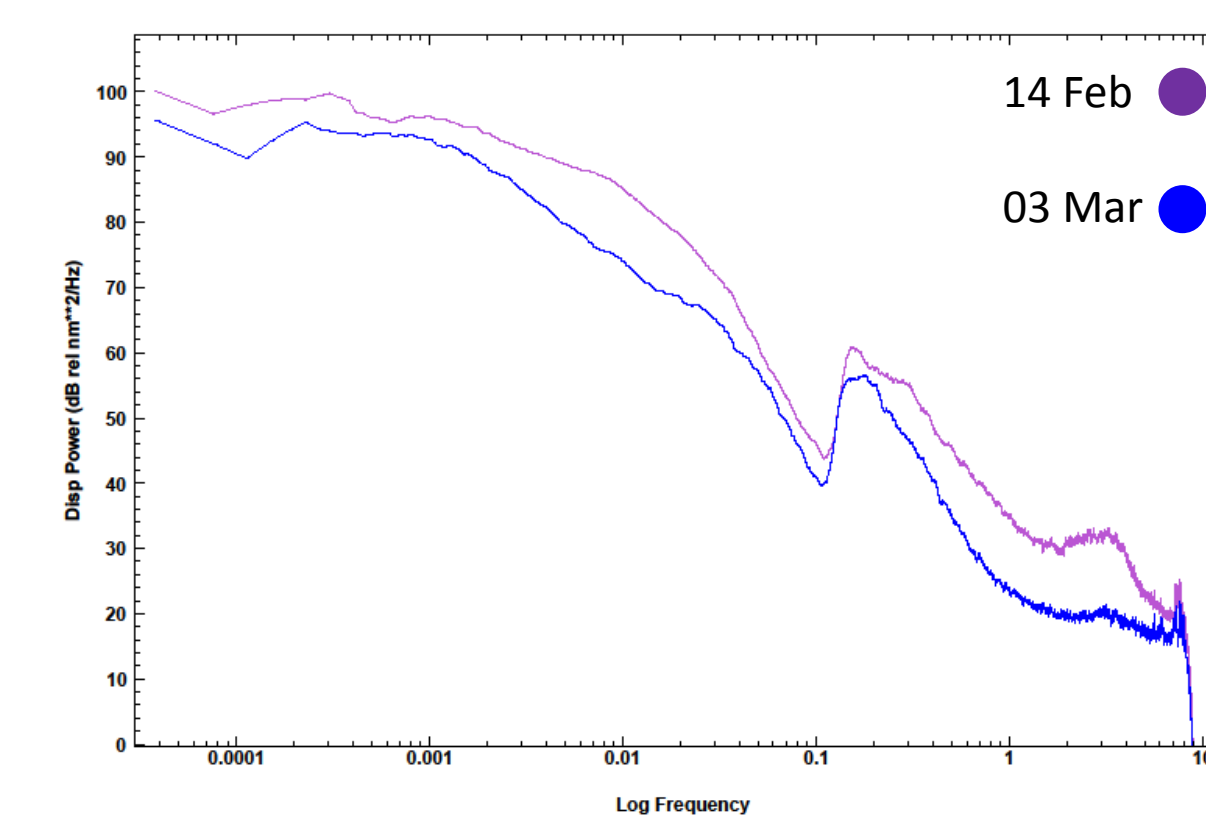
Due to the short time that was left of the week long visit, the best we achieved with the improvised technics, was we managed to enhance the noise reduction system from no pressure to a pressure of 3 to 0 (cero) Bar in 3 minutes and 48 seconds. All inlets where screwed again in the goosenecks and covered with gravel.
